City of Baltimore Wet Smoke and Dyed	Page 1 of 2	
Sewershed: Gwynns Falls	Company: Savin	Date: 4/21/2009
Test to be performed: Smoke Dyed Water X	Ground Condition: Dry ✓ Damp □ Wet □	Supervisor: <u>JAW</u>
Manhole_ID: S03K_015MH	Test ID: <u>D1032-002005</u>	Notification Made: NA (Residents, Fire, 311)

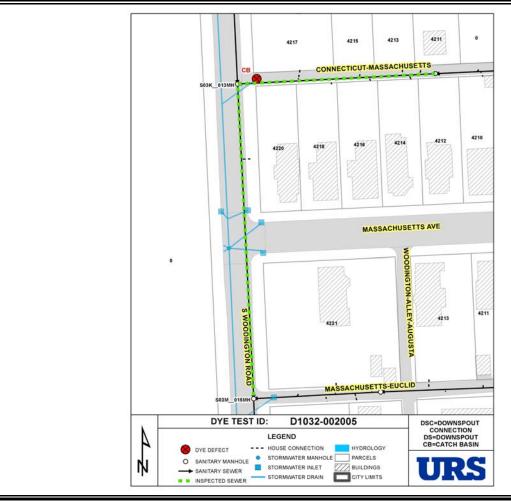
Field Sketch: Show all manholes with Numbers, Blower Placement Locations, Sandbag or Isolation Locations, Street Names, Building Addresses and Locations, Defect Locations and Photo Numbers.

Defect Loc	Obs_ClockFrom	Obs_ClockTo	Observation	Obs_Remarks
0			Manhole	S03K013MH
0			Start of Survey	
0			Water Level	
8			Dye Test Visible	@ IR, 1/8 GPM
8	08		Infil Runner	@ jt
11.80000019	09		Infil Runner	@ IR, 1/4 GPM
14.69999981			Dye Test Visible	@IR, 2 GPM
14.69999981	08		Infil Runner	@ jt
17.70000076			Dye Test Visible	@ IR, 3 GPM
17.79999924	09		Infil Runner	@ jt
23.29999924			Abandoned Survey	NO MORE DYE INFIL IN SEWER
